# Manhole Inspection Summary

Manhole # S11GG\_045MH

Insp Date: **7/10/08 9:20 AM**

**Location** Address: **REAR OF 3121 PRESBURY ST**

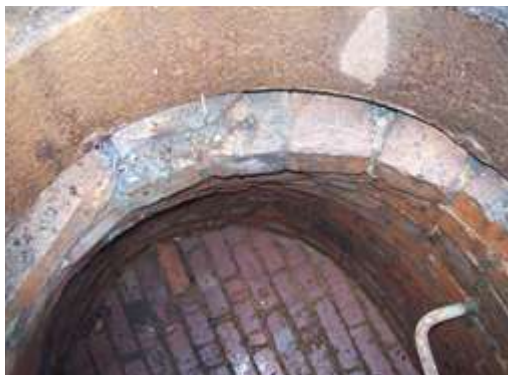
Defect 2

Condition: ☐ Sound ☒ **Cracked** ☐ Root Intrusion ☒ **Loose Brick** ☐ Deteriorated

CRACKED CHIMNEY

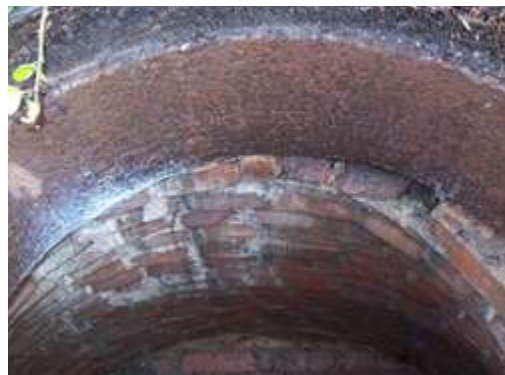
Defect 1

DETERIORATED CHIMNEY AND  
LOOSE BRICKS

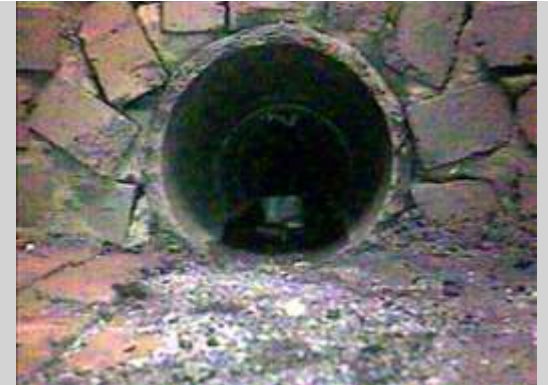
12 O'Clock Outflow

8 in. Circular Gravity Sewer  
Pipe Out @ 12 O'Clock

Pipe Material: **Clay** ☐ Pipe Lined

Infiltration: **None** Pipe Seal Cond: **Sound**
